Former RCA Taoyuan Plant Groundwater Remediation Site Remediation Plan Site Report

整治單位：台灣美國無線電公司

Presenter : TCETVT

2016/03/24

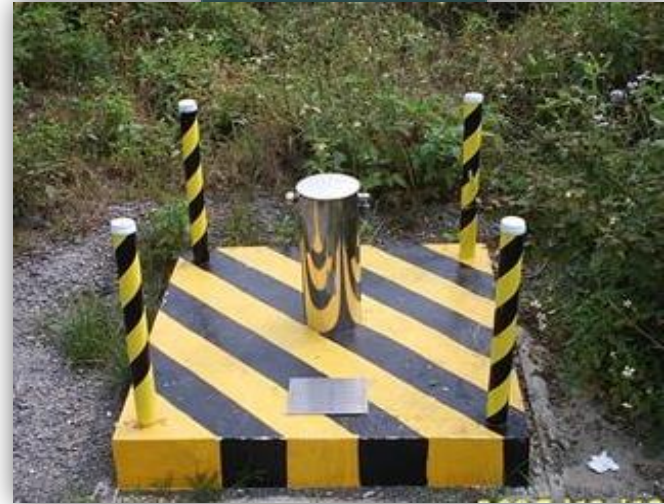
平臺式

Groundwater Monitoring Wells

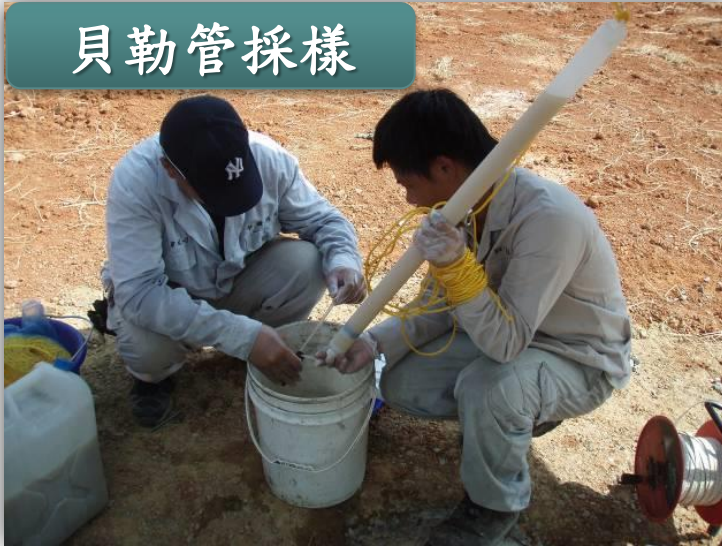
貝勒管採樣

Groundwater Sampling (2/2)

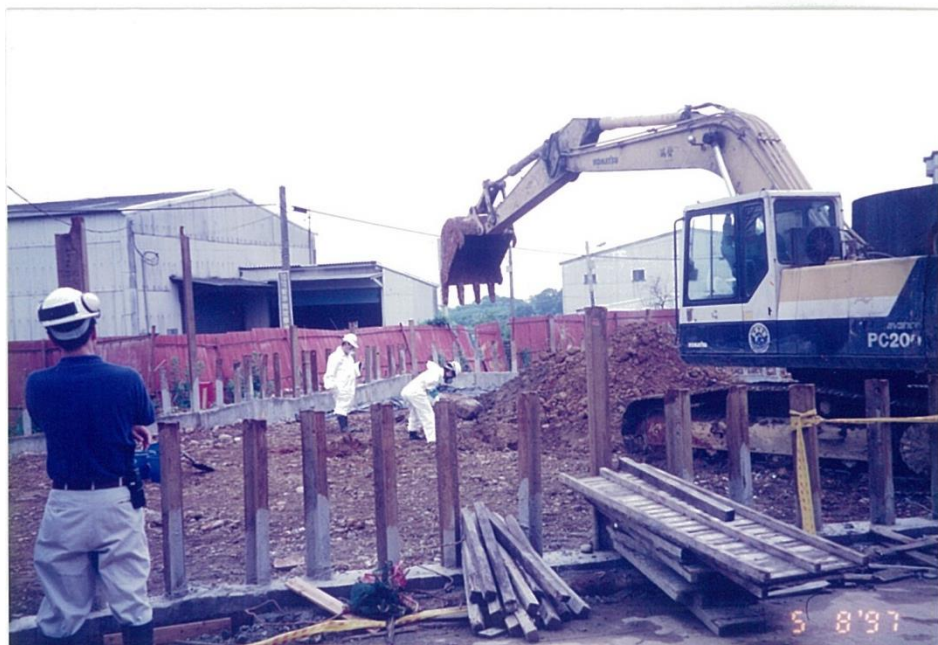
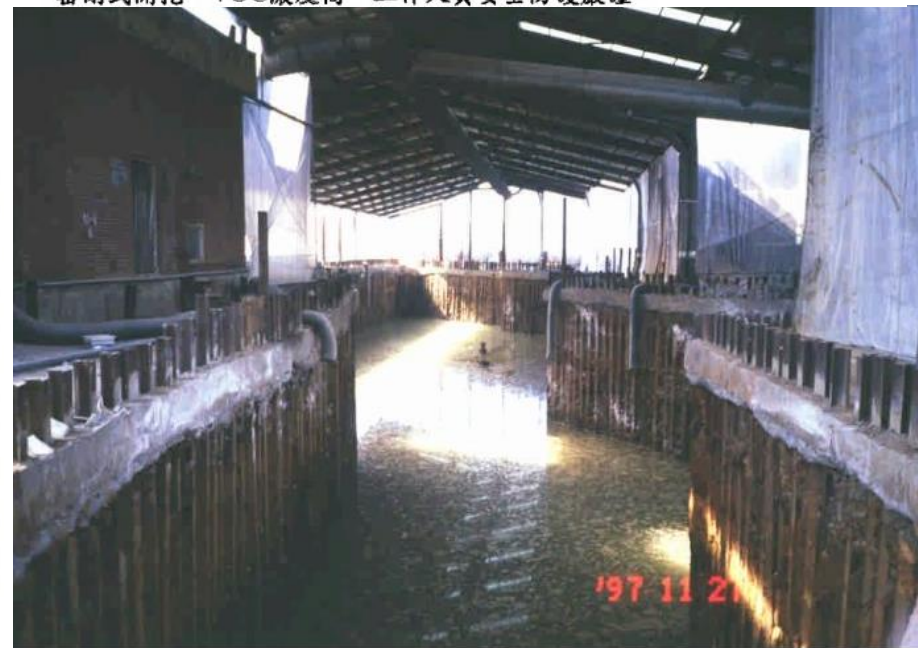
密閉式開挖：VOC濃度高，工作人員安全防護嚴謹。

開挖深度：6.1 m

地下水面：5.8 m

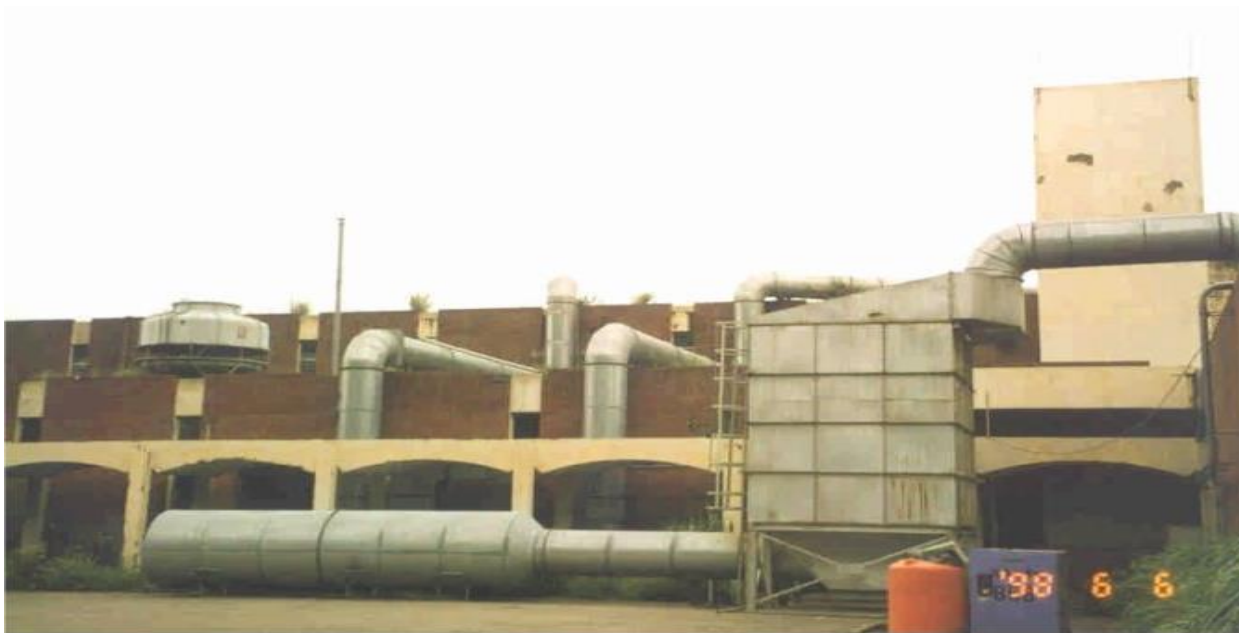
開挖之污染土壤在二號廠房內曝氣。

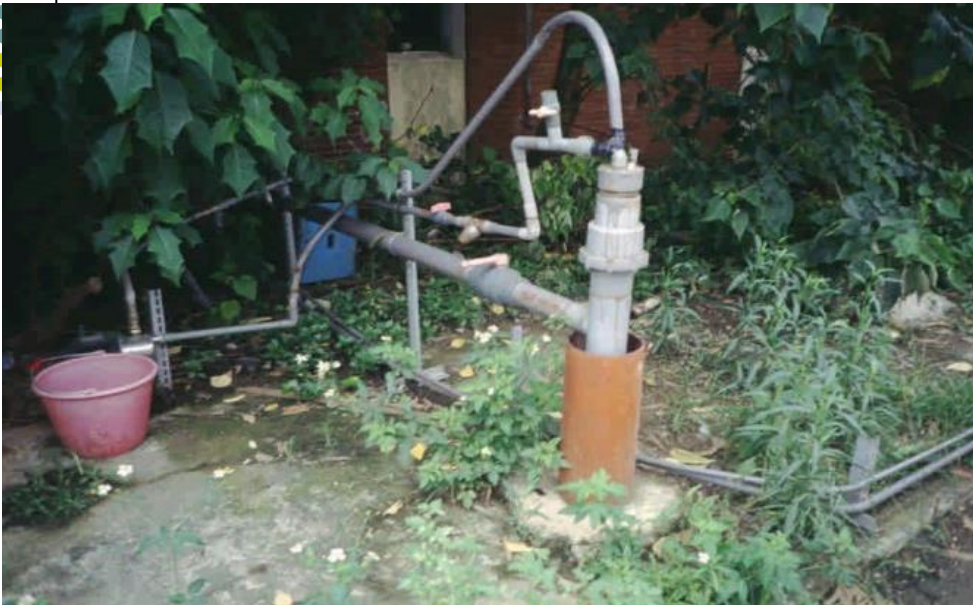
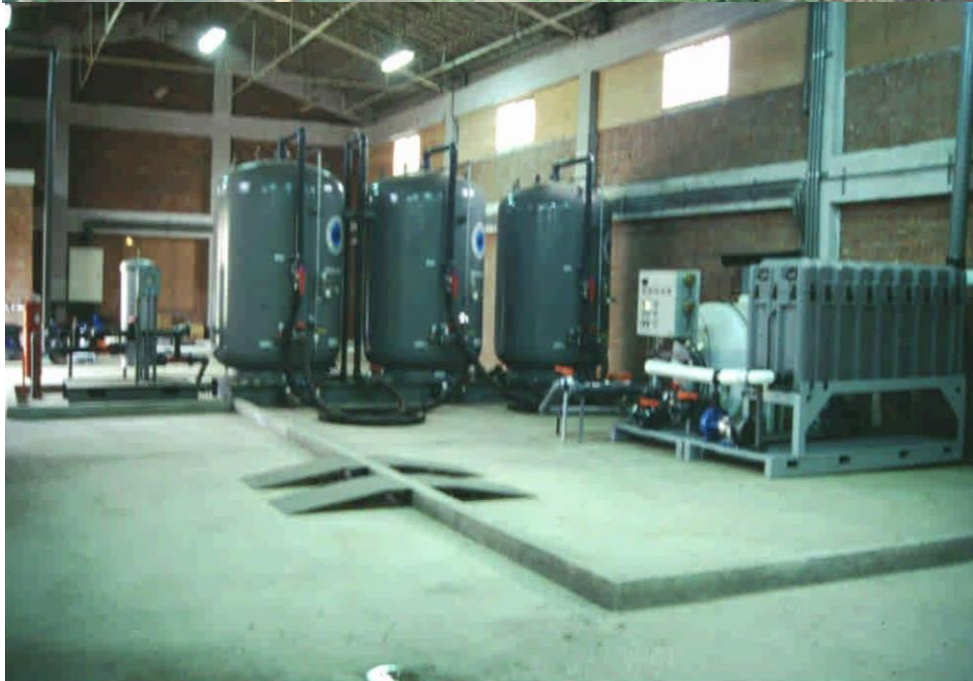
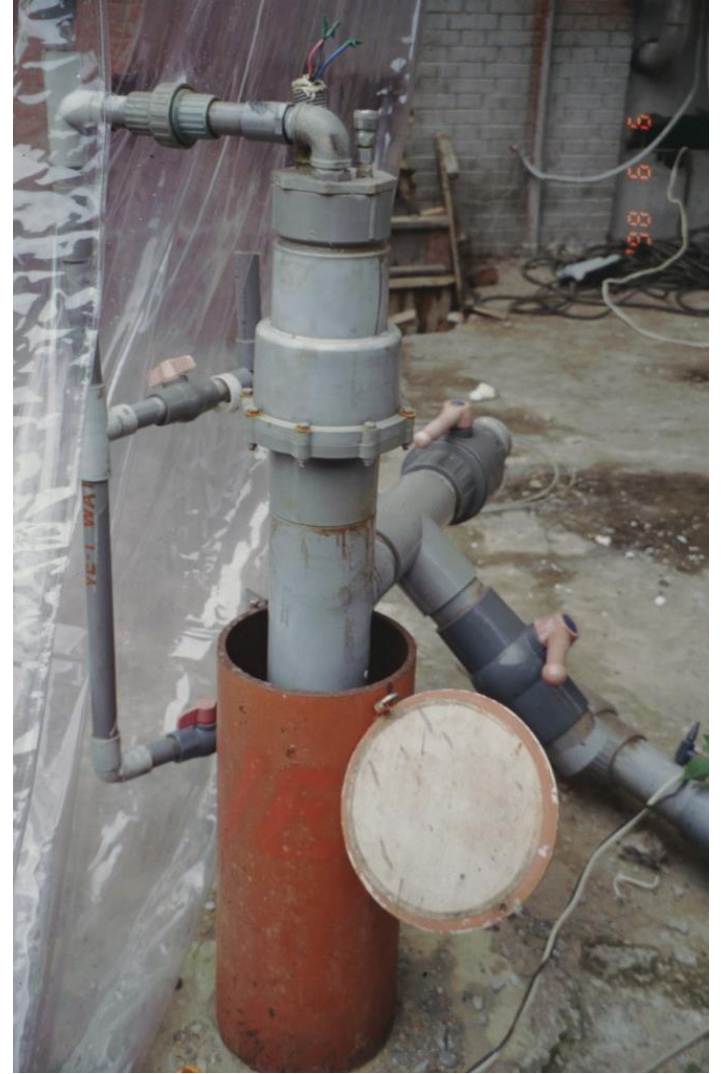
抽氣及處理系統

地下水處理系統

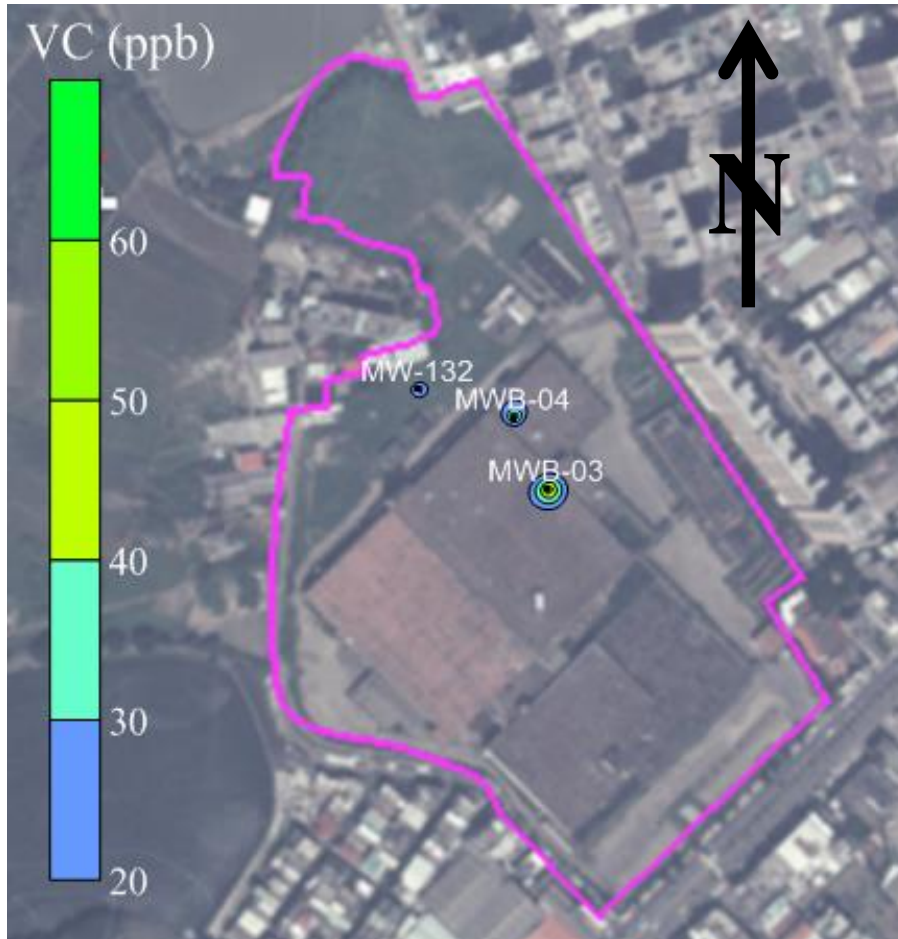
June 2015 Sampling Results

□ VC: MW-132 (38.2 ppb)
MWB-03 (60.1 ppb)
MWB-04 (44.9 ppb)

(經過糖蜜與乳酸鈉灌注後，
2015年6月採樣剩3口監測井VC
濃度超標。)

(With molasses and sodium lactate
injections, only 3 monitoring wells
exhibited VC exceedance in June 2015.)

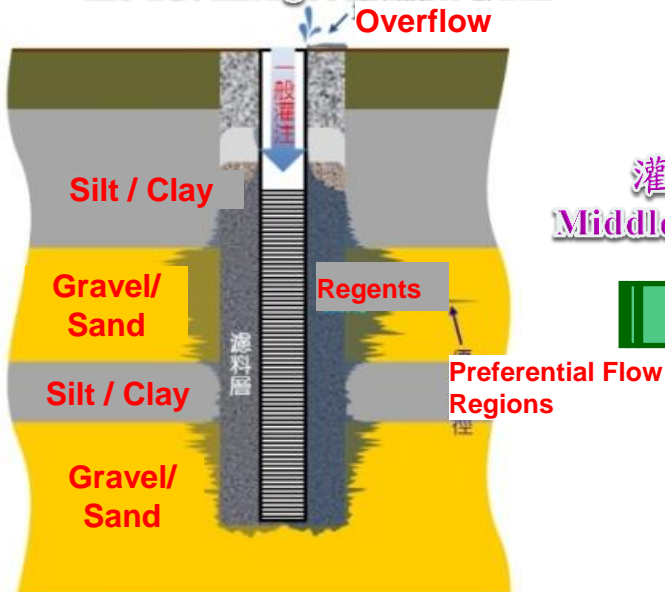
→ 遭遇坩黏土層或整治後期（產生大量生物膜），藥劑不易消散而累積於灌注井內，或沿灌注井與地層間細縫溢流至地表

In clay layers or the late stage of remediation period (producing great amount of biofilms), reagents easily accumulate in injection wells or flow out to the surface along the pores within layers.

藥劑灌注初期由優勢流徑傳遞
In the initial period, solution flows along the advantageous flow path

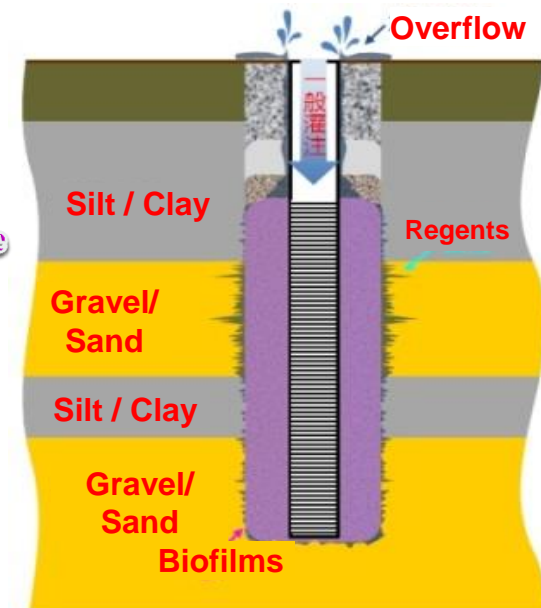
灌注中後期
Middle and late stage

Biofilms 阻塞縮限傳輸途徑
Blocks of biofilm limits the transition path

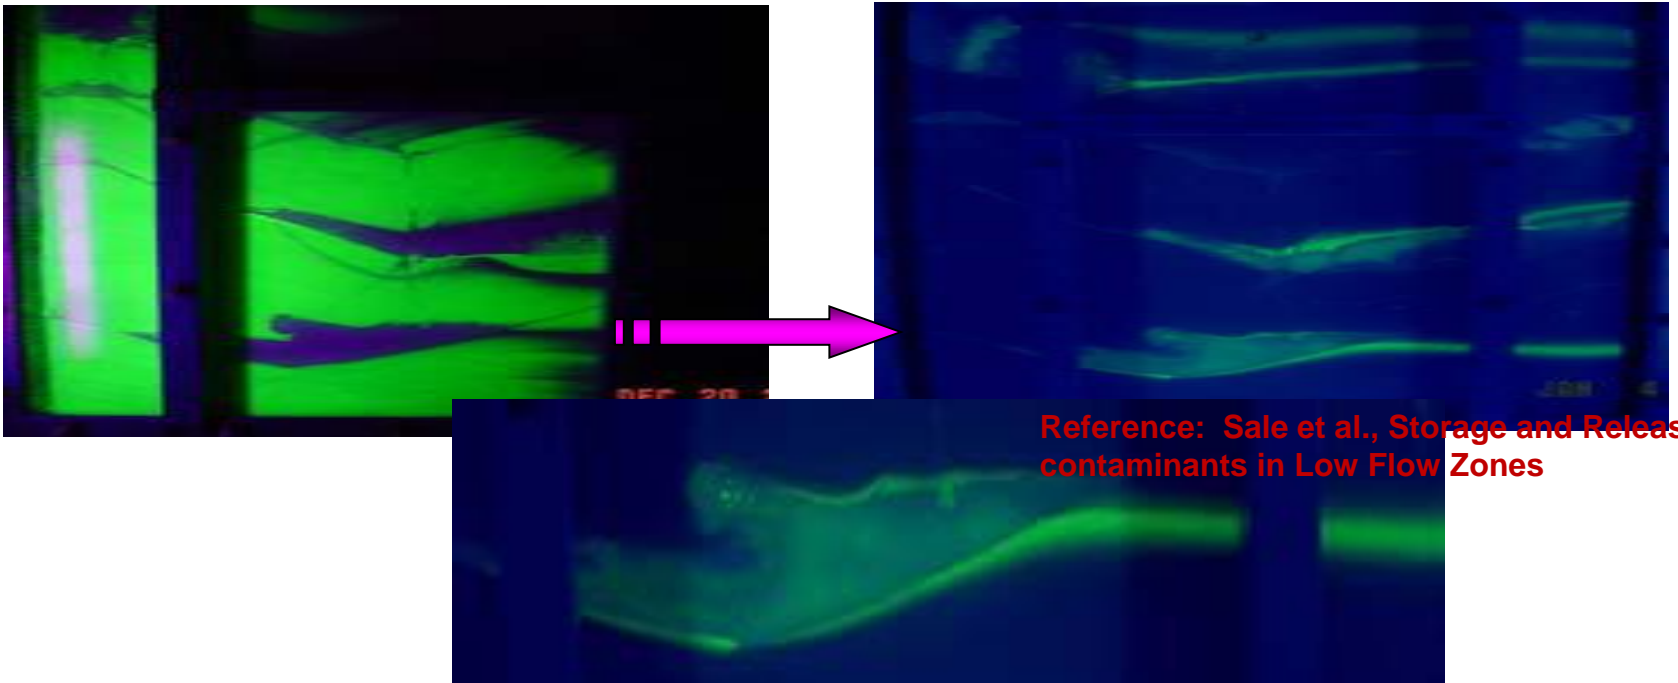
Pollution Transition in High/Low K Value Areas

- ❖ 污染團（**螢光綠**）初始進入砂層或高 K 區，溶質尚未進入黏土或低 K 區（**藍色**）
Initially, plumes (**Light Green**) flow into the sand layer or high K value areas. The solutes have not diffused into the clay layer or low K value area (**Blue**).
- ❖ **前進擴散 (Forward Diffusion)**：污染團經長期接觸擴散入黏土（**螢光綠**），砂層中污染團已流出或清除（**藍色**）
Forward Diffusion: with long-term contact, plumes diffuse into the clay layer (**Light Green**). Plumes in the sand layer are removed or flow out (**Blue**).
- ❖ **反向擴散 (Back Diffusion)**：黏土中之溶質回擴再次污染已乾淨之砂層，造成整治場址常見的**濃度穿透曲線之拖尾效應 (Tailing) 或濃度回升 (Rebound)** 現象
Back Diffusion: back diffusion of solutes in the clay layer again pollutes the clean sand layer, causing **Tailing or Rebound**.
