The Working Group on Remediation for
Soil and Groundwater Pollution of
Asian and Pacific Region

28 March 2023

Country Report: Republic of the Philippines Guidelines on Site Characterization and Remediation

Presented by:
Engr. Jean C. Borromeo
Environmental Management Bureau - NCR
Department of Environment and Natural Resources
Republic of the Philippines

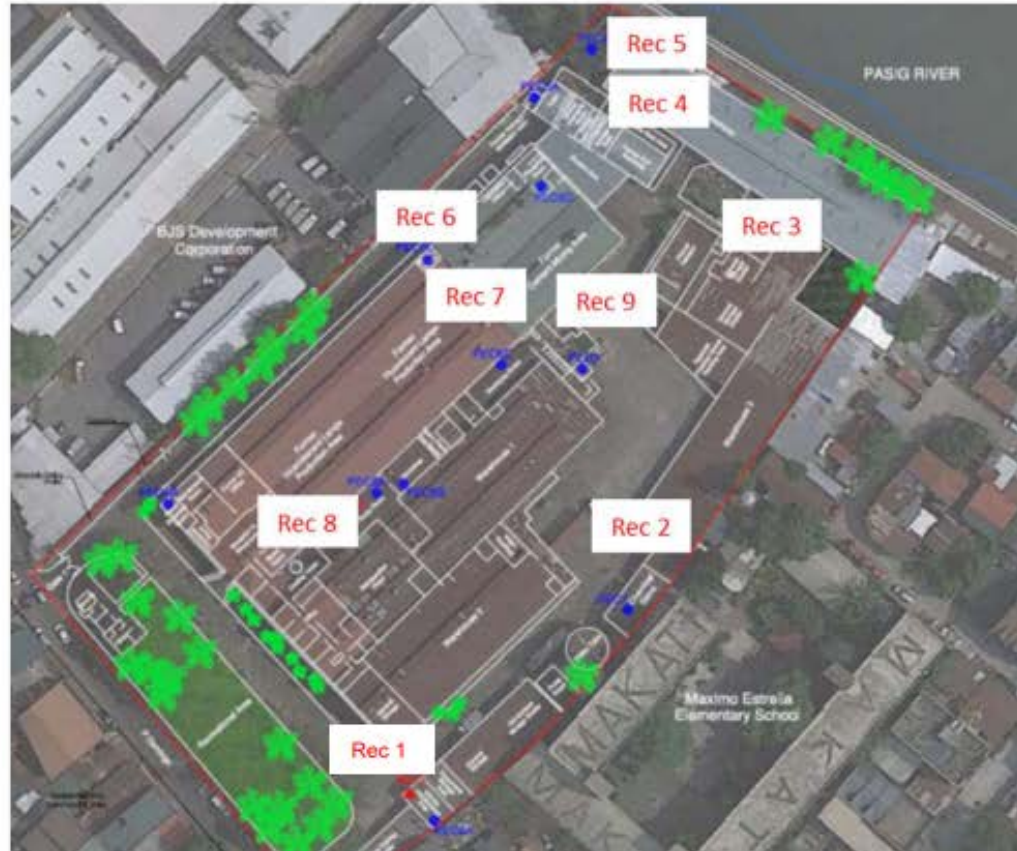
Recognized Environmental Conditions (REC)

1. Vehicle Maintenance Area
2. Warehouse 3
3. Vacuum Pump and Maintenance Room
4. Blue Warehouse
5. Former Wastewater Treatment Area
6. Storage Shelter Pits
7. Fluorescent Area Exhaust Machine
8. Pump Room
9. Sulfur Dioxide Cylinder Storage Area

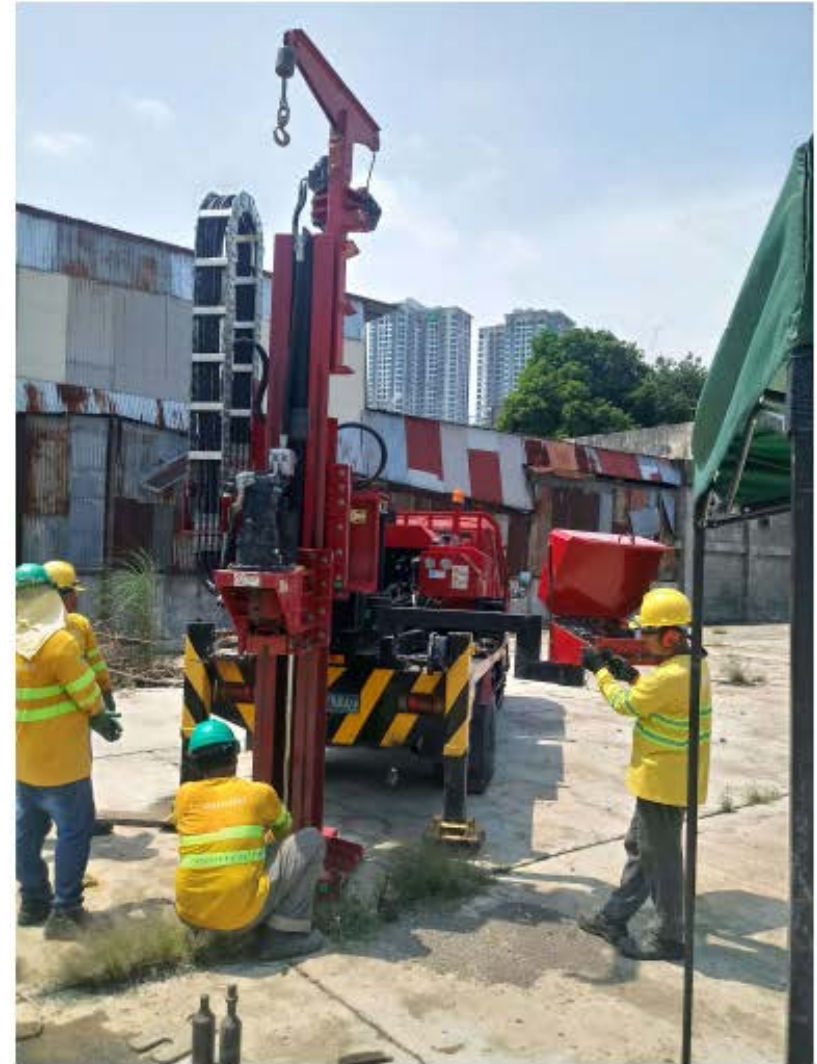
Site Investigation

- More than 100 soil borings were performed to evaluate subsurface conditions
- Environmental samples collected
 - Concrete
 - Building materials
 - Soil vapor
 - Fill
 - Soil
 - Groundwater
- Collective results informed demolition and remediation decision making

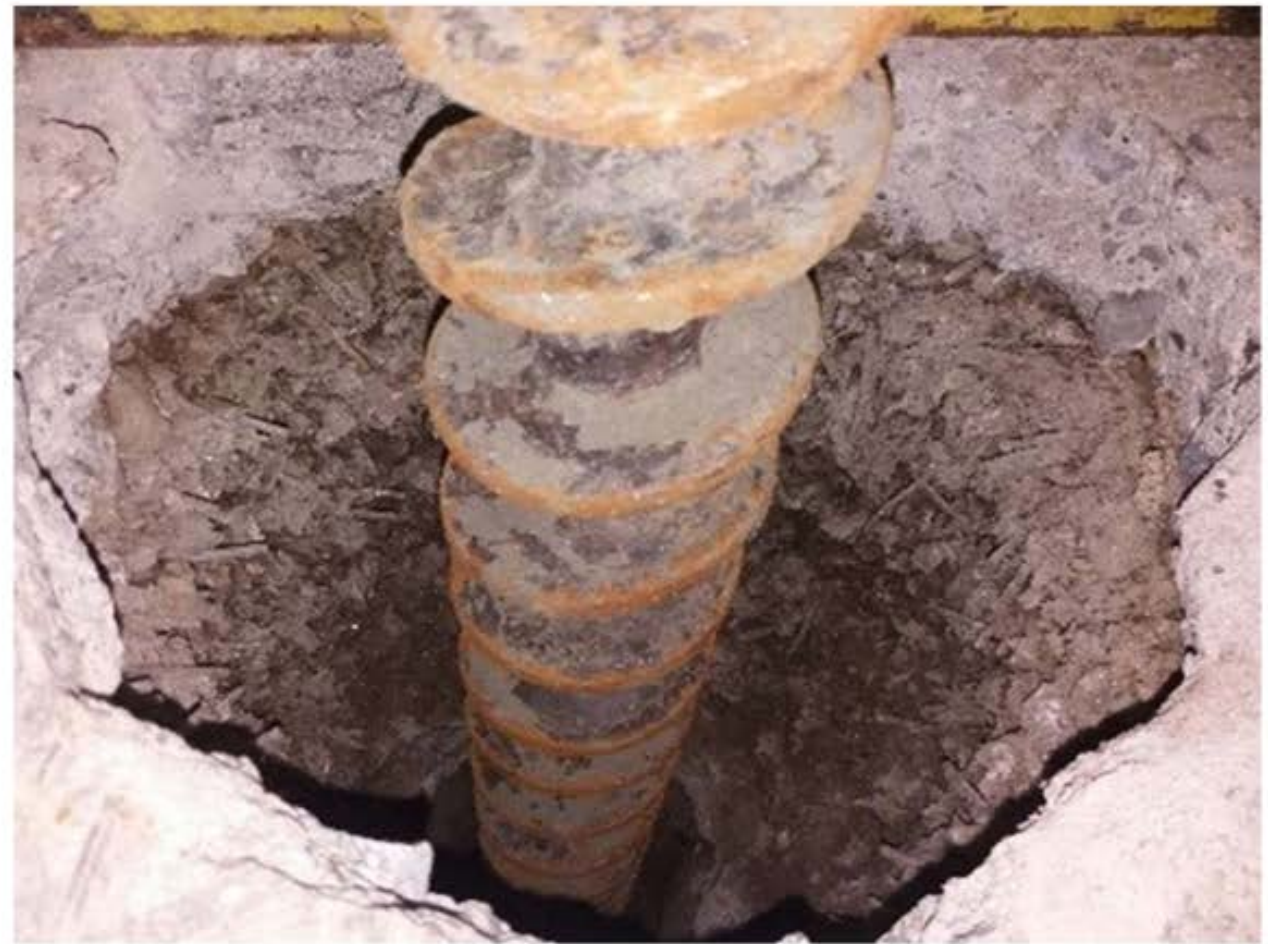
Soil Borings Encountered Glass Fill

- Glass with remnant debris of lighting manufacture found in multiple areas
- Glass percentage in fill varied widely; zones with 100% glass were found
- Confirmed contaminants
 - Antimony, Cadmium
 - Copper, Lead
 - Mercury, Nickel and Zinc
- Several samples determined as characteristic hazardous waste

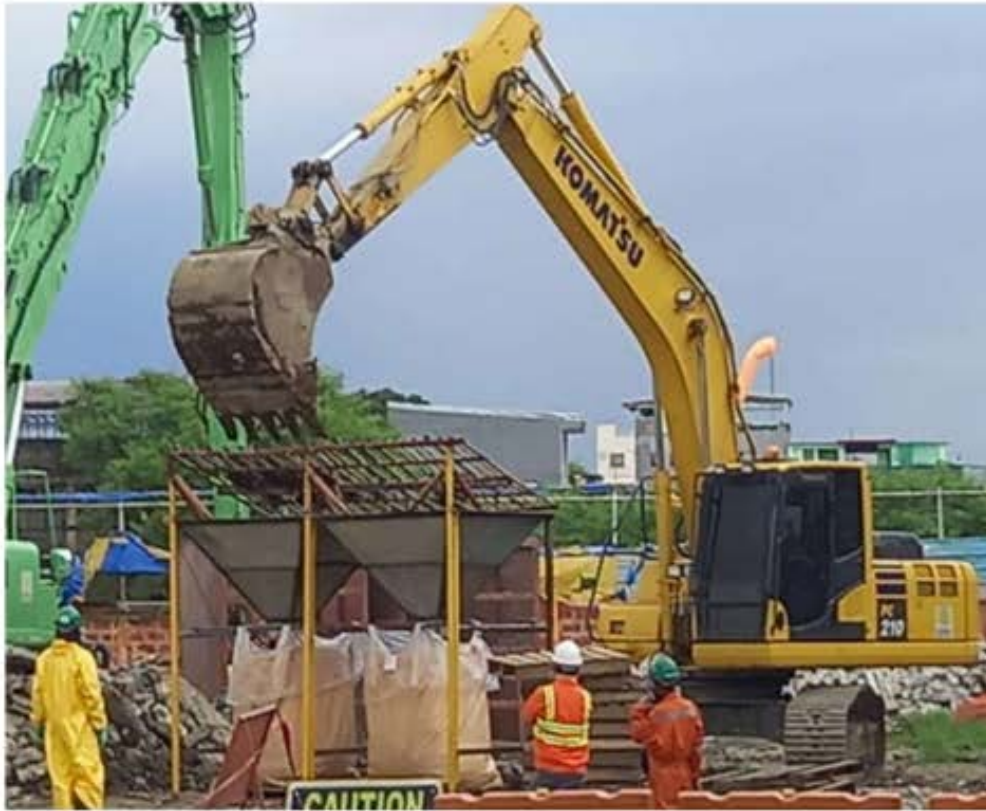
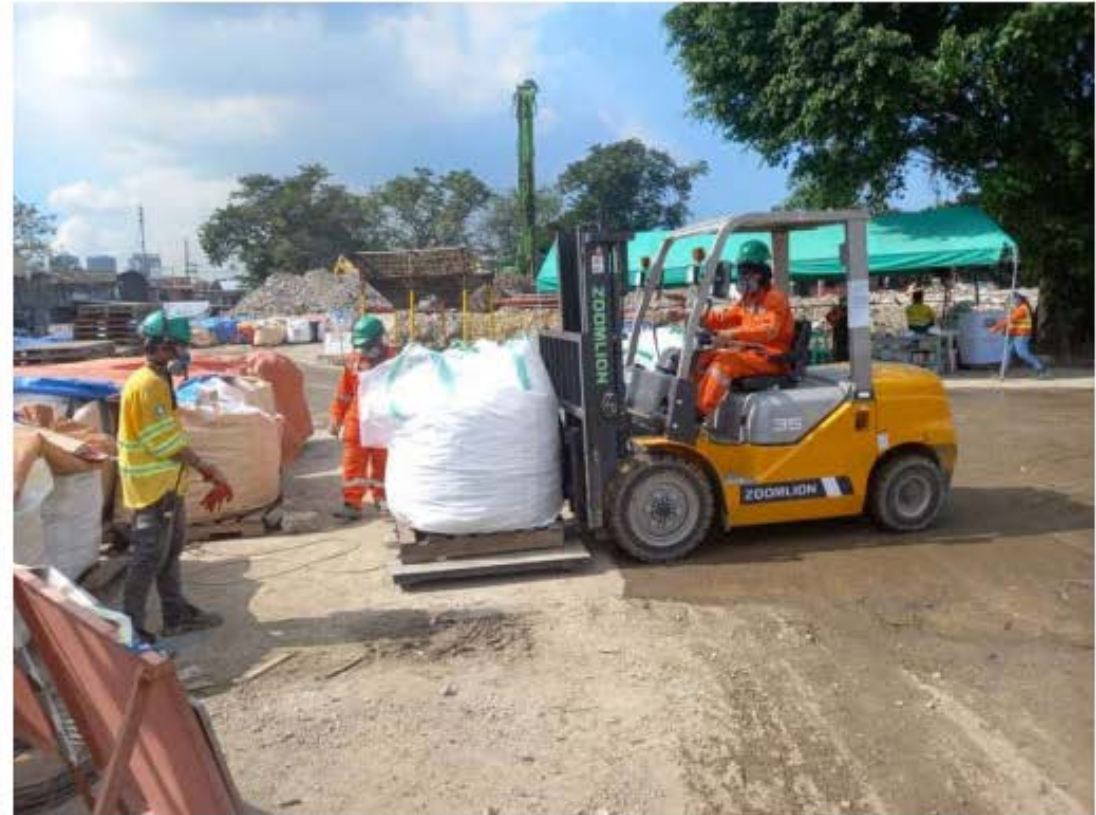
Excavation and Tonner Bag Transport

EXCAVATION, BAGGING AND TRANSPORTATION OF TONNER BAGS FROM AREA 7

- Excavation
 - Removal of subsurface materials >11 mg/kg mercury
- Backfill
 - Replacement with certified clean import soil and;
 - Reuse of clean crushed concrete from building demolition
- Excavated Soil
 - Staged in tonner bags; stored on site until disposed
 - Characterized every 10 m^3 for waste disposal purposes
- Disposal
 - Hazardous – Dolomatrix Treatment followed by Metro Clark landfill
 - Non-hazardous – Direct transport to Metro Clark landfill

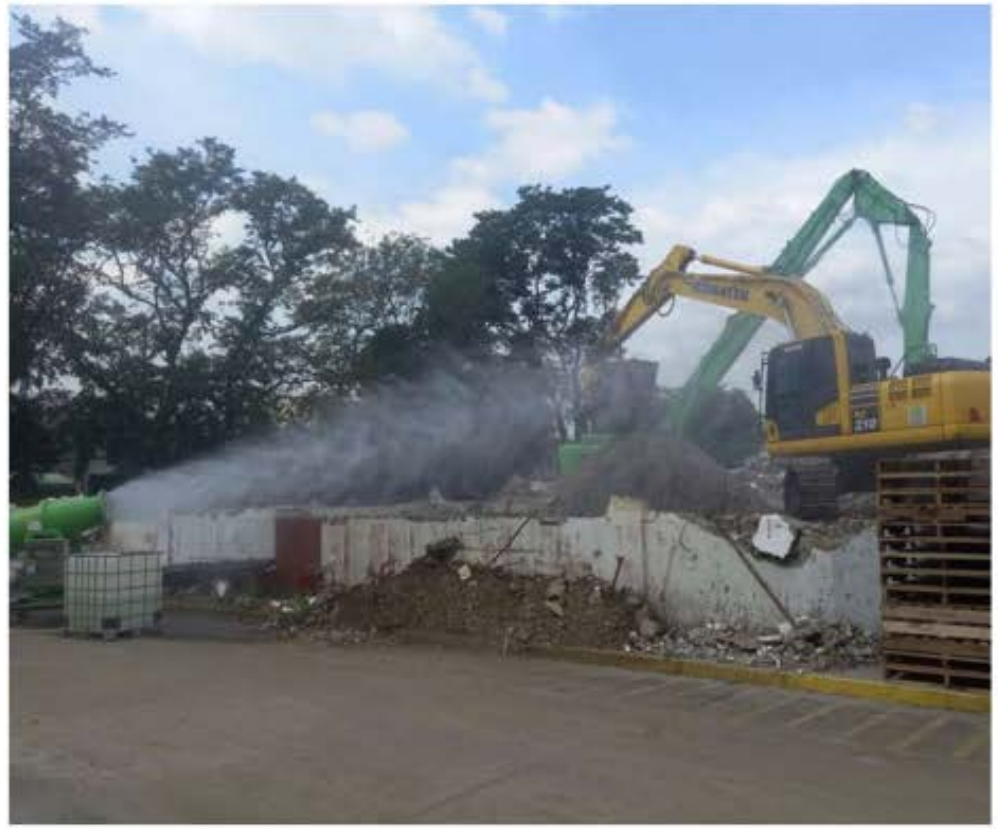
Water Cannon Provides Dust Control

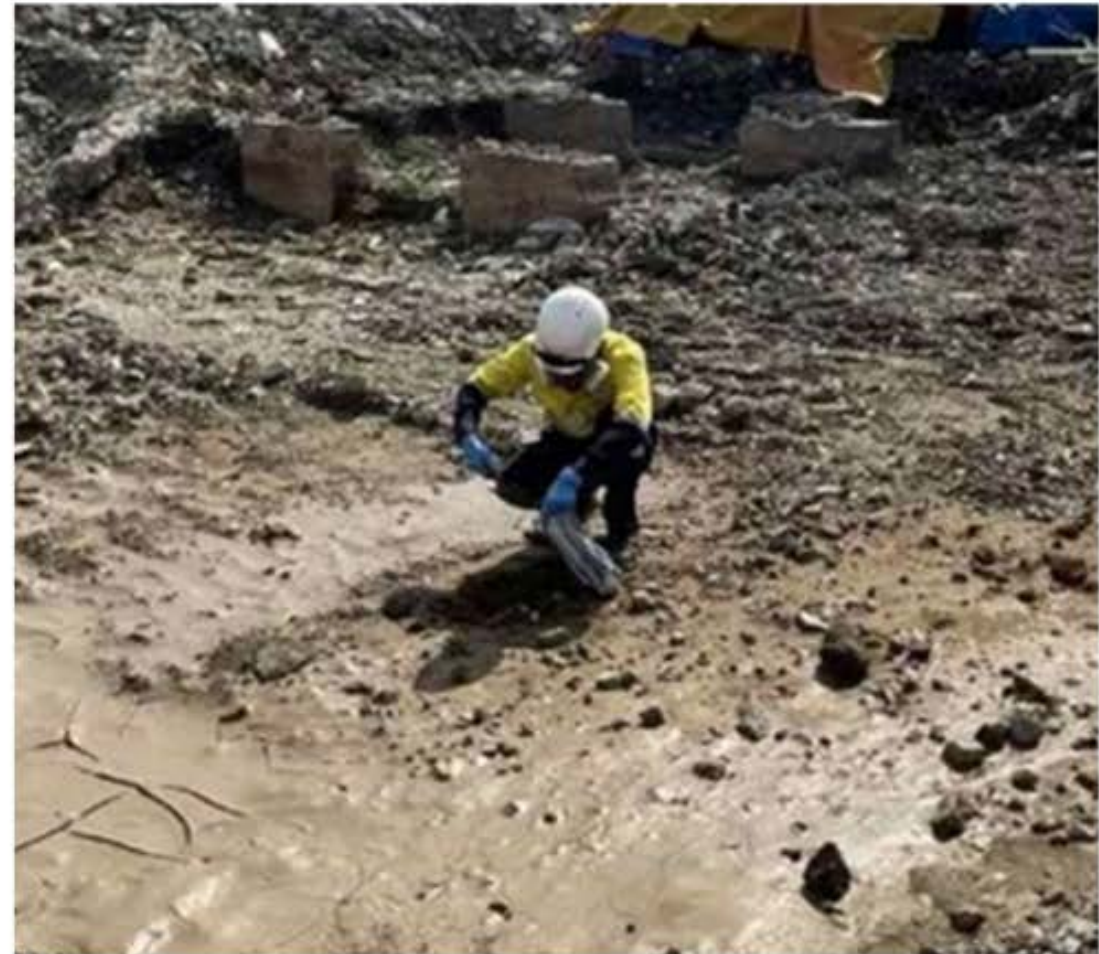
Confirmation Sampling

- As defined by the Remedial Action Plan

Location	Collection Summary	Collection Frequency
Sidewall	Samples collected from exterior perimeter of RAP defined excavation area only. Samples to be collected at the midpoint between ground surface and excavation depth up to a maximum of 2m.	Where feasible, one confirmation sample will be collected for every 15m of exposed excavation sidewall.
Bottom (<2m bgs)	Grab soil sample collected from RAP defined excavation areas which are less than 2m in total depth.	One confirmation sample will be collected per every 250 square meters excavated
